ESC Model 3800 Leakage Detector

Description

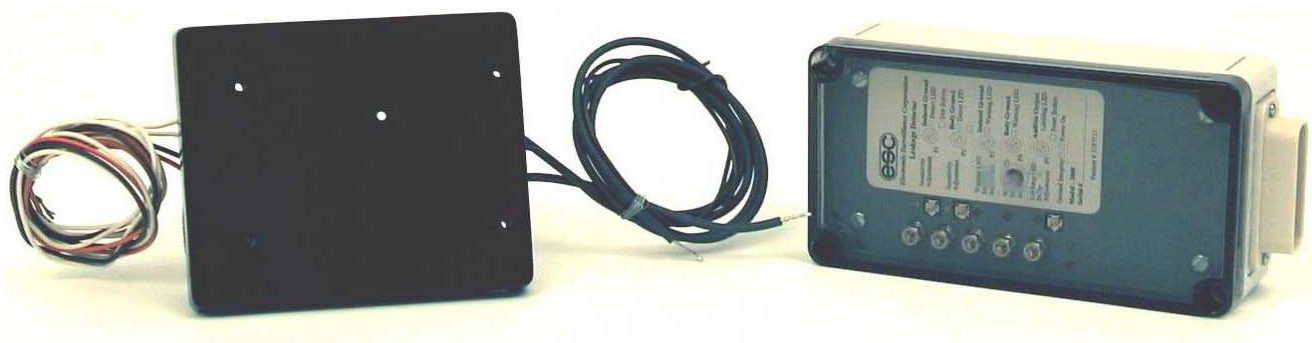
3800-1 Module

3800-2 Module

The detector consists of 3 main components – the 3800-1 high voltage module, the 3800-2 detector module, and a remote control / display panel that is provided by the vehicle manufacturer.

- **Small Size** – The 3800-2 detector module measures only 3.7" x 7.1" x 2.3". The 3800-1 high voltage module measures 5.5" x 4.5" x 0.8".
- **Weatherproof Housing and Wiring Harness Connector** – The 3800-2 detector module is encased in a NEMA 4 rated polycarbonate box complete with a 24-pin dust and moisture resistant automotive style connector. The 3800-1 high voltage module is cast in epoxy and is completely waterproof.

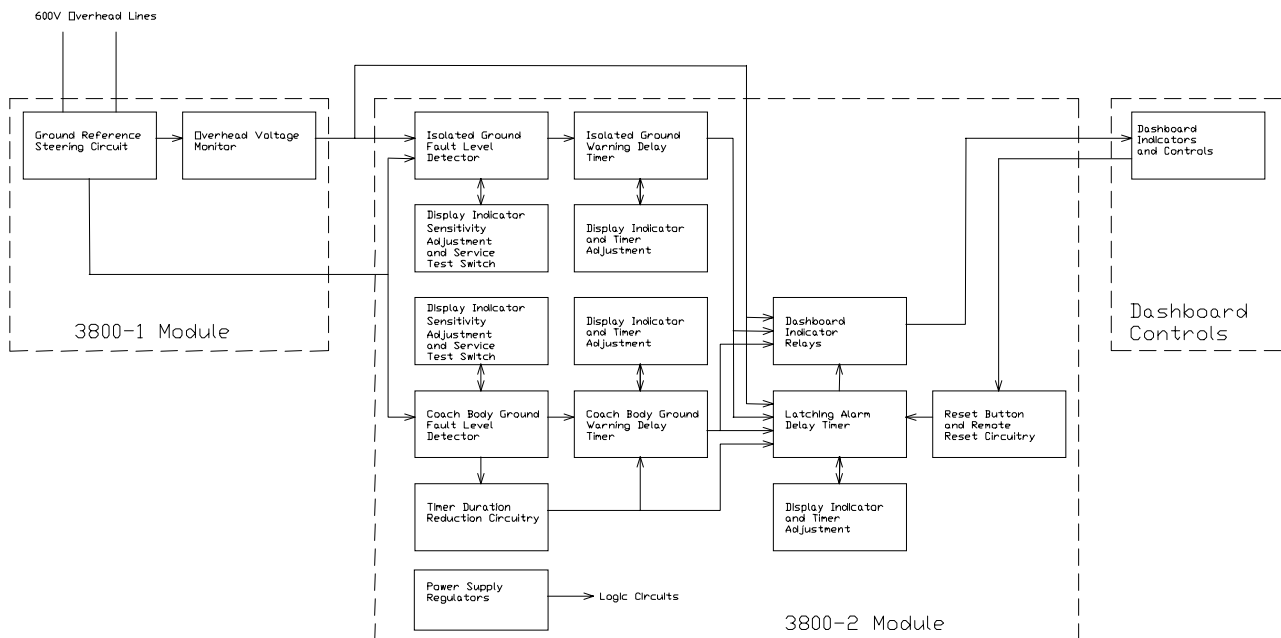
Block Diagram

A simple block diagram of the 3800 Leakage Detector.
